**Flood Control Project Maintenance
Levee Inspections**

Fall 2018 Levee Maintenance Deficiency Summary Report

**Flood Control Project Maintenance
Levee Inspections****LMA District Cover Sheet
Fall 2018 Levee Inspection Results****Knights Landing Ridge Drainage District**

Knights Landing Ridge Drainage District

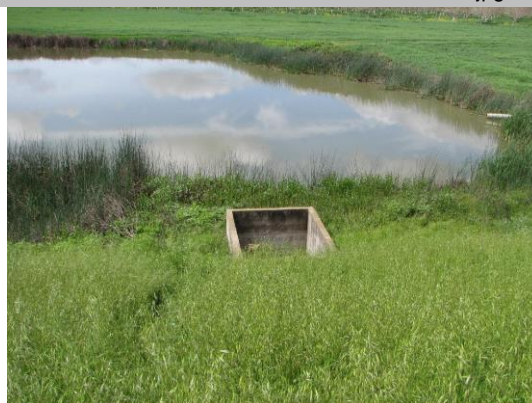
Photo 1 of 3 : UCIP_FA_2018_48010_21582.jpg

Comment Code					
Inspector Comment					
FS_ID:48010 DS_ID:19360 EP_NO: 9302 Repair Type: No Action Needed Crossing Status: Found UCIP Comments: Pipe has been grouted in place under permit 18987, 2015Pipe completely rusted through on LS slope of levee at toe/headwall of concrete distribution box. Pipe needs replacement or proper abandonment. Pipe not visible at outlet. FIELD_STRUCT_DESC: *ABANDONED* 36-inch corrugated metal drainage pipe through the levee, 27 feet below the crown. Slide gate on the waterside (WS) end. 12-foot by 6-foot concrete box on the landside (LS) end. (36-inch pipe [HLM 1.62] authorized under Automatic Board Order (ABO) issued as Permit No. 9302, 1974 - Barbara Lowe Elliott; 36-inch pipe abandoned by removing ends and pumping pipe full of concrete under Permit No. 18987, 2016 - Knaggs Ranch, LLC, care of John Brennan). [Additional Reference(s): DWR Levee Log, 1990. USACE Sacramento O&M Manual 127, June 1953, (Station 0+30)]. FS Date: 5/16/2016 3:59:29 PM

Concrete distribution box on LS toe.

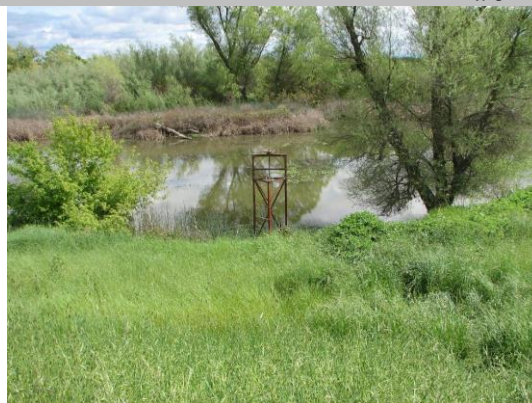
Photo 2 of 3 : UCIP_FA_2018_48010_21581.jpg

Slide gate on metal stand on WS toe. Pipe opening not visible.

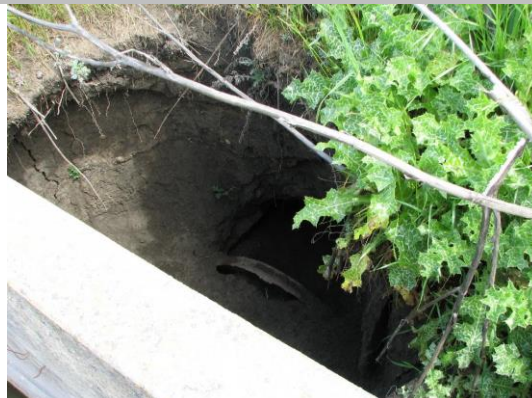
Photo 3 of 3 : UCIP_FA_2018_48010_21580.jpg

Comment Code						
Inspector Comment						
FS_ID:48010						
DS_ID:19360						
EP_NO: 9302						
Repair Type: No Action Needed						
Crossing Status: Found						
UCIP Comments: Pipe has been grouted in place under permit 18987, 2015Pipe completely rusted through on LS slope of levee at toe/headwall of concrete distribution box. Pipe needs replacement or proper abandonment. Pipe not visible at outlet.						
FIELD_STRUCT_DESC: *ABANDONED* 36-inch corrugated metal drainage pipe through the levee, 27 feet below the crown. Slide gate on the waterside (WS) end. 12-foot by 6-foot concrete box on the landside (LS) end. (36-inch pipe [HLM 1.62] authorized under Automatic Board Order (ABO) issued as Permit No. 9302, 1974 - Barbara Lowe Elliott; 36-inch pipe abandoned by removing ends and pumping pipe full of concrete under Permit No. 18987, 2016 - Knaggs Ranch, LLC, care of John Brennan). [Additional Reference(s): DWR Levee Log, 1990. USACE Sacramento O&M Manual 127, June 1953, (Station 0+30)].

Pipe failure at connection to concrete box on LS toe.

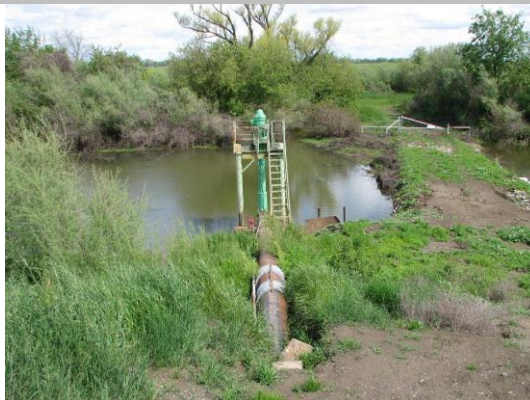
Photo 1 of 3 : UCIP_FA_2018_11064_18426.jpg

Comment Code						
Inspector Comment						
FS_ID:11064						
DS_ID:19361						
EP_NO: 9302						
Repair Type: Non-Urgent						
Crossing Status: Found						
UCIP Comments: Pipe exposed on WS slope in trench may need to be backfilled to prevent erosion under pipe.						
FIELD_STRUCT_DESC: 20-inch steel irrigation pipe through the levee, 8.8 feet below the crown. Pump on a steel pile structure at the waterside (WS) toe. Siphon breaker in a 12-inch steel riser on the landside (LS) slope. Possible butterfly valve at the LS toe. (Permit No. 9302, 1974 - Barbara Lowe Elliott). [Additional Reference(s): DWR Levee Log, 1990. USACE Sacramento O&M Manual 127, June 1953, (Station 32+94)].						
FS Date: 4/5/2013

Pump on pile at WS toe with pipe in open trench on LS slope.

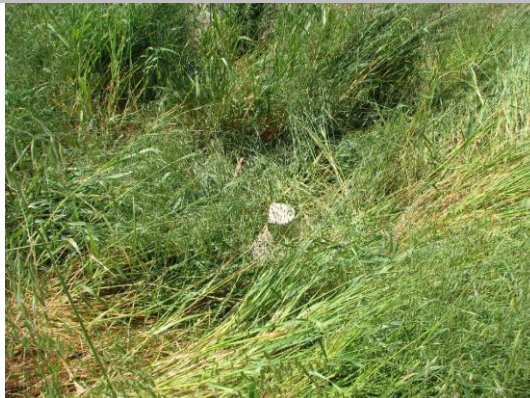
Photo 2 of 3 : UCIP_FA_2018_11064_18425.jpg

Siphon breaker in 12-inch steel riser on LS slope.

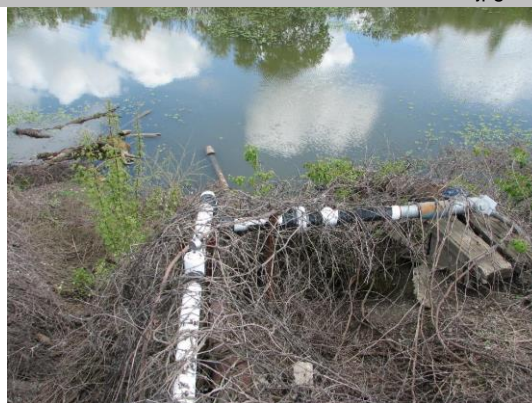
Photo 1 of 3 : UCIP_FA_2018_11065_18429.jpg

FS_ID:11065
DS_ID:19362
EP_NO: 9305
Repair Type: Non-Urgent
Crossing Status: Found
UCIP Comments: Slope on WS shoulder appears to be eroding at pipes exit from levee. 36-inch conc riser on LS is filled with mud.
FIELD_STRUCT_DESC: 10-inch steel irrigation pipe through the levee, 5.8 feet below the crown. Pump at the waterside (WS) toe. 36-inch concrete standpipe at the landside (LS) toe. (Permit No. 9305, 1974 - Albert L. Bacchini). 5-inch steel pipe sleeved through the 10-inch pipe. Annular space grouted. (Permit No. 6076, 1968 - Albert L. Bacchini).
[Additional Reference(s): DWR Levee Log, 1990. USACE Sacramento O&M Manual 127, June 1953, (Station 47+00) (11-inch pipe listed)].
FS Date: 4/5/2013

Pump on WS shoulder overgrown and may be abandoned.

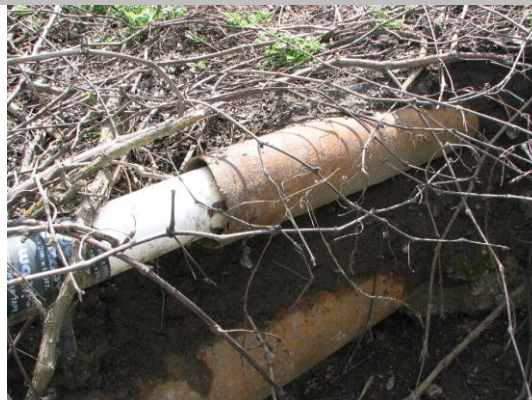
Photo 2 of 3 : UCIP_FA_2018_11065_18428.jpg

Erosion at pipes exit from levee on WS shoulder.

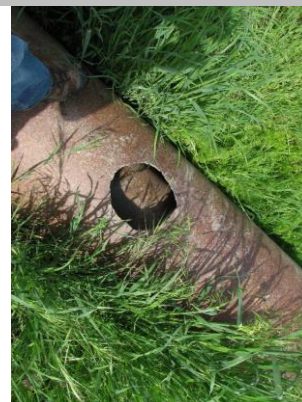
Photo 1 of 3 : UCIP_FA_2018_13204_21588.jpg

Comment Code					
Inspector Comment					
FS_ID:13204					
DS_ID:19363					
EP_NO: 9302					
Repair Type: Non-Urgent					
Crossing Status: Found					
UCIP Comments: Space between 16-inch and 24-inch pipe should be grouted. There is no pump on stand at WS toe.					
FIELD_STRUCT_DESC: 24-inch steel irrigation pipe through the levee, 5.9 feet below the crown. 16-inch steel pipe sleeved through this pipe.					
No visible control valves. Pump on a pile structure in the stream.					
Siphon breaker on the landside (LS) slope. Pipe discharges into a concrete irrigation ditch off the LS toe. (Permit No. 939, 1943 - W. K. Lowe). [Additional Reference(s): DWR Levee Log, 1990. USACE Sacramento O&M Manual 127, June 1953, (Station 71+25)].					
FS Date: 4/5/2013

16-inch pipe sleeved through 24-inch pipe on WS slope.

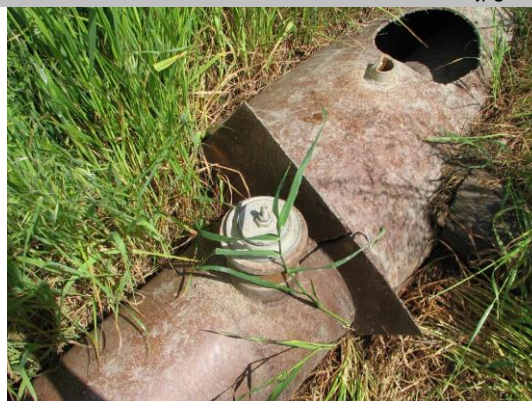
Photo 2 of 3 : UCIP_FA_2018_13204_21590.jpg

Siphon breaker on LS slope.

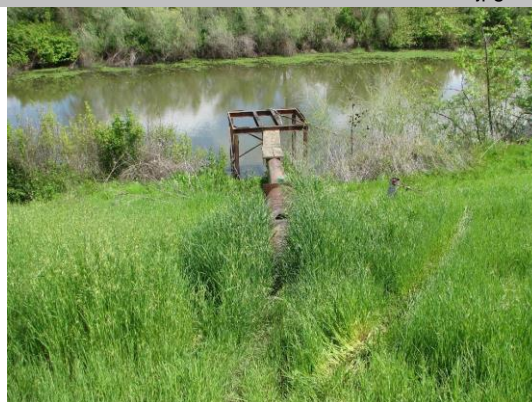
Photo 3 of 3 : UCIP_FA_2018_13204_21589.jpg

Pipe and pier on WS toe.

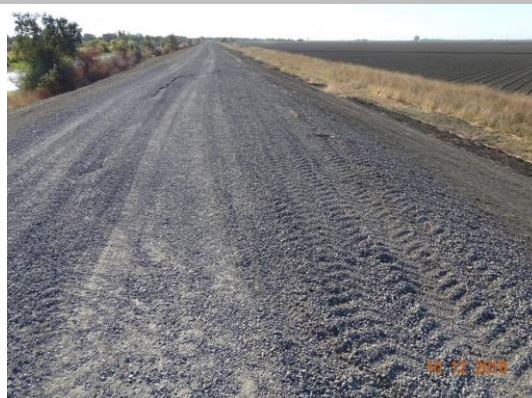
Photo 1 of 1 : FA_2018_NA0008_256_23_20181012_00044.jpg

LM Start	2.23	Rating **	M	Issue No.	23
LM End	2.23	Issue Type +	Ma	Location *	CR
Category	Earthen Levee			GPS Latitude/Longitude	
				Start	End
Item	Cracking			38.742899 °	38.742899 °
				-121.690897 °	-121.690897 °
DWR ID	DWR_NA0008_01_f_2018_23				
Comment Code					
CR1 : Monitor and have inspected by geotechnical engineer.					
Inspector Comment					
50' crack on the crown at previous sloughing site. There appears to be no bulge or sloughing on the landside slope. Slight settlement on the crown. Recommend monitoring.

View of crack and settlement on the crown. Fall 2018.

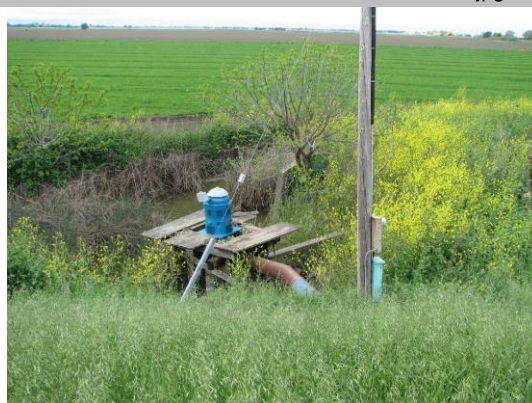
Photo 1 of 1 : UCIP_FA_2018_11067_18431.jpg

Comment Code						
Inspector Comment						
FS_ID:11067 DS_ID:19364 EP_NO: 9307 Repair Type: Non-Urgent Crossing Status: Found UCIP Comments: Siphon breaker on LS burried or broken off and missing. FIELD_STRUCT_DESC: 1 of 2: 14-inch steel drainage pipe through the levee, 5.4 feet below the crown. Pump house on a pile structure at the landside (LS) toe. Siphon breaker on the LS slope. Service pole and anchor at the LS toe. (14-inch pipe [HLM 2.62] authorized under Automatic Board Order (ABO) issued as Permit No. 9307, 1974 - Azalene E. Lowe; a 12-foot section of an existing 14-inch pipe on LS replaced and name change under Permit No. 9307-1, 2016 - Ann Grube). [Additional Reference(s): DWR Levee Log, 1990. USACE Sacramento O&M Manual 127, June 1953, (Station 123+25)]. FS Date: 4/5/2013

Pump and pipe on LS toe.

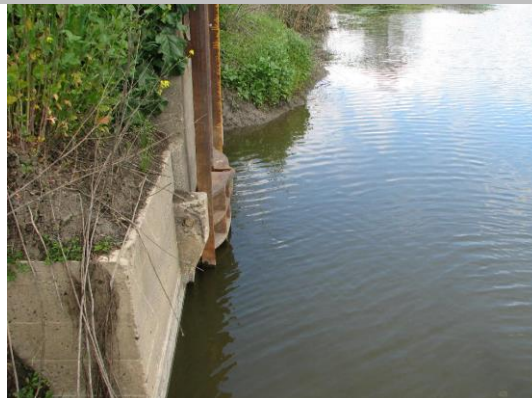
Photo 1 of 3 : UCIP_FA_2018_13205_21602.jpg

Comment Code						
Inspector Comment						
FS_ID:13205						
DS_ID:19391						
EP_NO: 9307						
Repair Type: Non-Urgent						
Crossing Status: Found						
UCIP Comments: Walkway to actuator slide gate is missing. No method of actuating slide gate.						
FIELD_STRUCT_DESC: 2 of 2: 48-inch by 48-inch reinforced concrete box drainage culvert through the levee, 23 feet below the crown.						
Walkway to slide gate on the waterside (WS) end. Concrete headwalls on both ends. Service pole and anchor at the landside (LS) toe.						
Concrete headwalls on both ends. (four foot by four foot culvert [HLM 2.62] authorized under Automatic Board Order (ABO) issued as Permit No. 9307, 1974 - Azalene E. Lowe). [Additional Reference(s): DWR Levee Log, 1990. USACE Sacramento O&M Manual 127, June 1953, (Station 123+55.5)].						
FS Date: 4/5/2013

Slide gate and concrete headwall on WS toe.

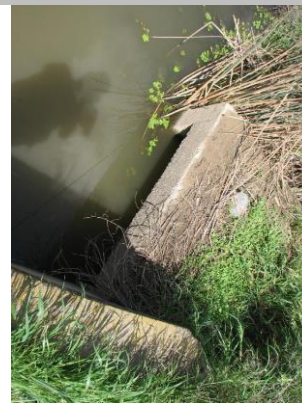
Photo 2 of 3 : UCIP_FA_2018_13205_21601.jpg

Concrete inlet on LS toe.

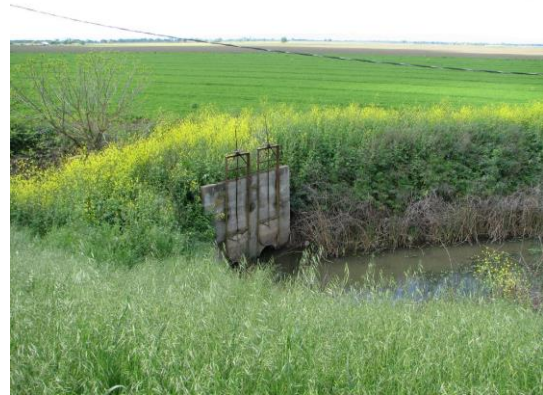
Photo 3 of 3 : UCIP_FA_2018_13205_21605.jpg

Inlet located next to concrete headwall on LS toe.

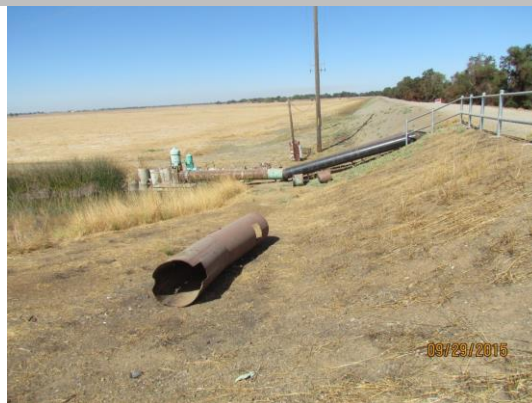
Photo 1 of 2 : FA_2018_NA0008_256_18_20180904_00003.jpg

LM Start	2.70	Rating **	M	Issue No.	18
LM End	2.70	Issue Type +	En	Location *	LS
Category	Earthen Levee			GPS Latitude/Longitude	
				Start	End
Item	Encroachments			38.748837 °	38.748837 °
				-121.694823 °	-121.694823 °
DWR ID	DWR_NA0008_01_f_2015_18				
Comment Code					
DE : Debris					
Inspector Comment					
Portion of the pipe seems to be replaced and the abandoned pipe is left at the toe of the landward side of the levee.

View of the abandoned pipe at the toe of levee on the landward side.
Fall 2015.

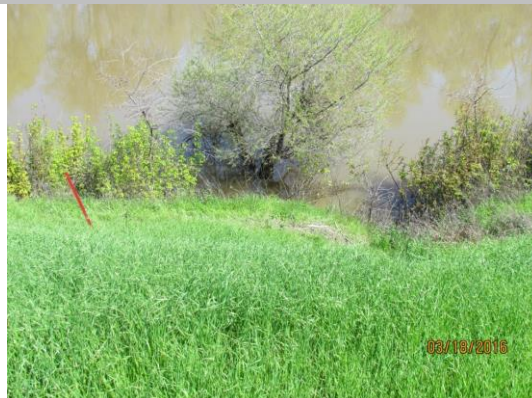
Photo 1 of 1 : FA_2018_NA0008_256_31_20180904_00011.jpg

View of the erosion at the toe of the levee on the waterward side. Spring 2016.

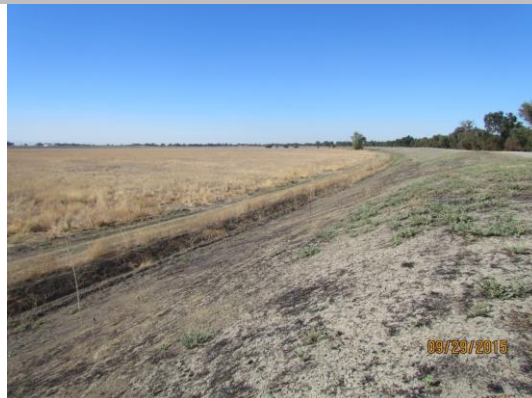
Photo 1 of 1 : FA_2018_NA0008_256_22_20180904_00008.jpg

View of the ditch on the landward side of the levee looking upstream. Fall 2015.

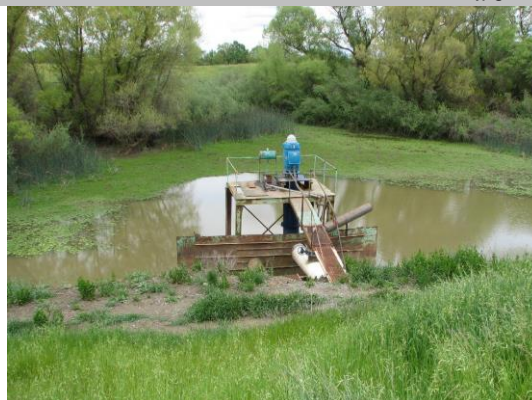
Photo 1 of 3 : UCIP_FA_2018_41068_18643.jpg

Comment Code						
Inspector Comment						
FS_ID:41068 DS_ID:19397 EP_NO: 5276 Repair Type: Non-Urgent Crossing Status: Found UCIP Comments: Pipe appears abandoned at this time. FIELD_STRUCT_DESC: 2 of 2: 20-inch steel irrigation pipe through the levee, 4.9 feet below the crown. Vertical pump unit on pile structure in stream. Siphon breaker on the landside (LS) shoulder in a 16-inch steel riser. Flap gate on the LS end. Pipe discharges into an irrigation ditch on the LS. Steel plate welded over end of pipe at pump structure. (Replaced an existing 18-inch pipe at this location under Permit No. 5276, 1966 - Reclamation District No. 730). [Additional Reference(s): DWR Levee Log, 1990]. FS Date: 4/5/2013

Pump on steel structure at WS toe.

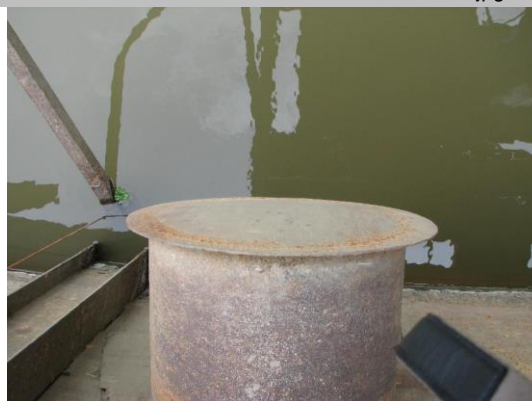
Photo 2 of 3 : UCIP_FA_2018_41068_18642.jpg

Steel plate welded over pipe end at pump platform.

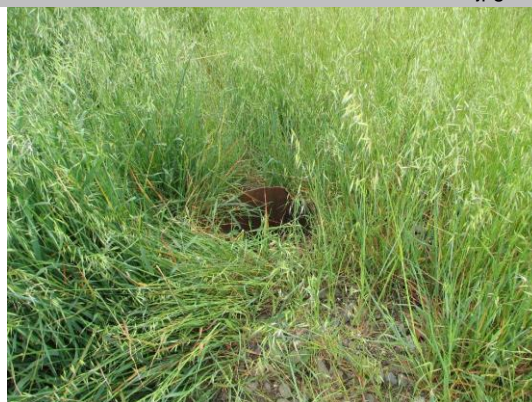
Photo 3 of 3 : UCIP_FA_2018_41068_18641.jpg

Siphon breaker buried inside 16-inch steel riser on LS shoulder.

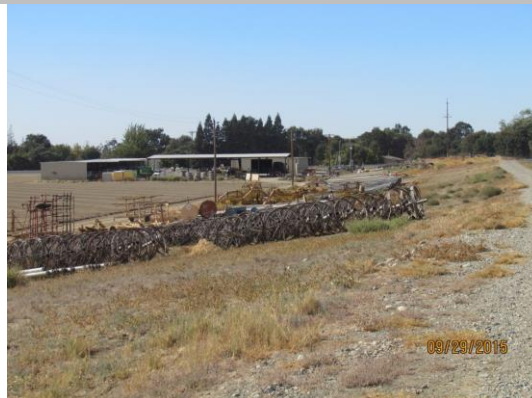
Photo 1 of 2 : FA_2018_NA0008_256_7_20180904_00001.jpg

View of the equipment on the landward side of the levee looking upstream. Fall 2015.

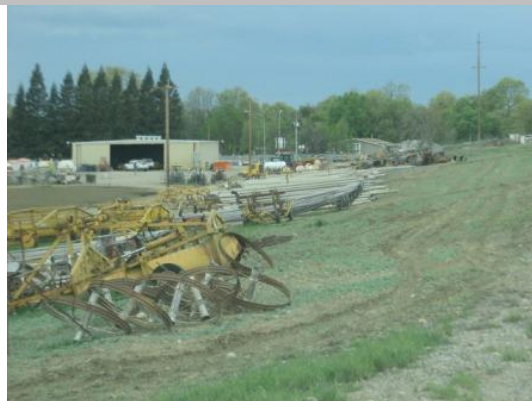
Photo 2 of 2 : FA_2018_NA0008_256_7_20180904_00002.jpg

A current view of the equipment on the levee slope. Spring 2014

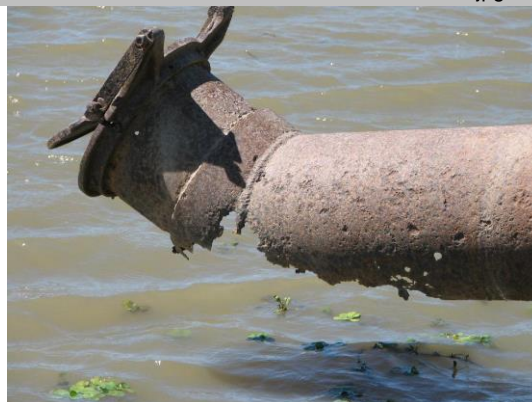
Photo 2 of 3 : UCIP_FA_2018_52538_18705.jpg

Pipe rusted through at flap gate on WS toe.

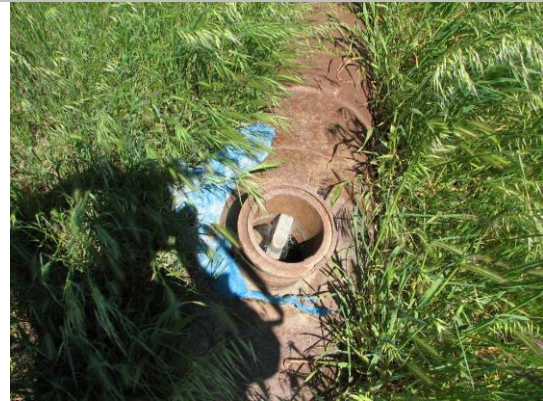
Photo 2 of 3 : UCIP_FA_2018_11289_18664.jpg

Missing siphon breaker on LS slope.

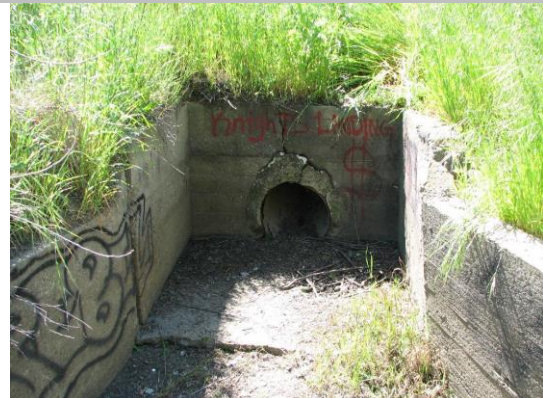
Photo 3 of 3 : UCIP_FA_2018_11289_18663.jpg

Concrete headwall and distribution box at outlet on LS toe. Pipe heavily corroded.

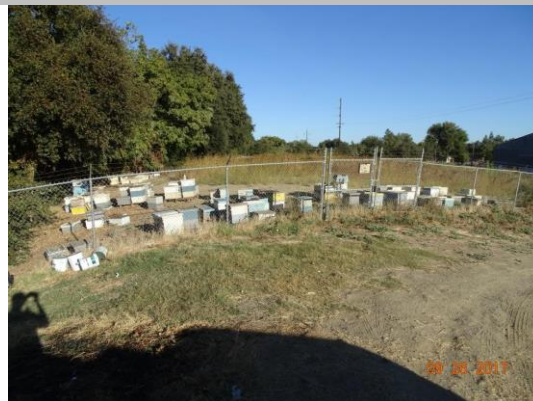
Photo 1 of 2 : FA_2018_NA0008_257_1_20180904_00001.jpg

View of the fence on the crown. Fall 2017.

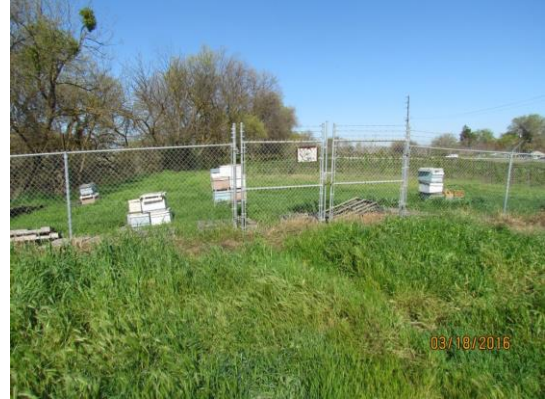
Photo 2 of 2 : FA_2018_NA0008_257_1_20180904_00002.jpg

View of the fence on the crown of the levee looking upstream. Spring 2016.
